## ASBESTOS REGISTER

DATE: AUGUST 2019

OUR REFERENCE:  
C124464 : J163425

ST MARKS COLLEGE  
BOSCO (SECONDARY) CAMPUS  
455 THE TERRACE, PORT PIRIE SA 5540

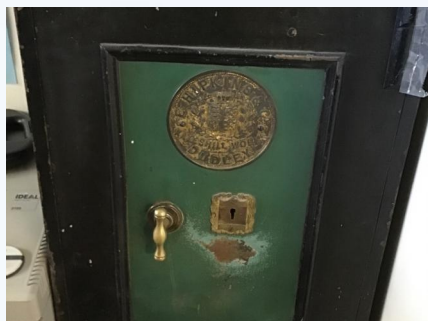
PHOTO NO.: J163425-9235A-PHOTO100  
 RESULT: ASBESTOS - PRESUMED POSITIVE  
 BUILDING/LEVEL: ADMINISTRATION BUILDING - GROUND LEVEL  
 ROOM/LOCATION: STORE ROOM, ADJACENT MALE TOILET - NORTH  
 FEATURE/MATERIAL: SAFE - INSULATION - SAFE  
 SAMPLE NO.: NOT SAMPLED RESTRICTED ACCESS

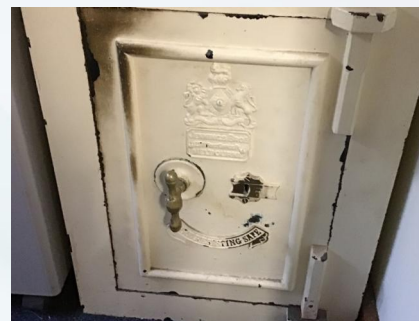
PHOTO NO.: J163425-9235A-PHOTO101  
 RESULT: ASBESTOS - PRESUMED POSITIVE  
 BUILDING/LEVEL: ADMINISTRATION BUILDING - GROUND LEVEL  
 ROOM/LOCATION: STORE ROOM, ADJACENT MALE TOILET - NORTH  
 FEATURE/MATERIAL: SAFE - INSULATION - SAFE  
 SAMPLE NO.: NOT SAMPLED RESTRICTED ACCESS

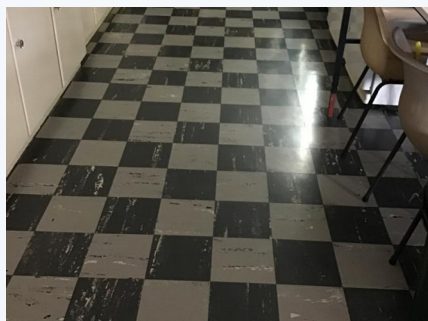
PHOTO NO.: J163425-9235A-PHOTO048  
 RESULT: ASBESTOS - PRESUMED POSITIVE  
 BUILDING/LEVEL: CHAPEL, BISHOP GALLAGHER, CANTEEN & STAFF BUILDING - GROUND LEVEL  
 ROOM/LOCATION: CANTEEN - FOOD PREP AREA  
 FEATURE/MATERIAL: FLOOR COVERING - VINYL TILES & ADHESIVE  
 SAMPLE NO.: SIMILAR TO: J163425-9235A-023

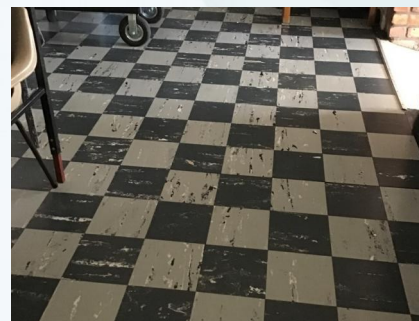
PHOTO NO.: J163425-9235A-PHOTO049  
 RESULT: ASBESTOS - PRESUMED POSITIVE  
 BUILDING/LEVEL: CHAPEL, BISHOP GALLAGHER, CANTEEN & STAFF BUILDING - GROUND LEVEL  
 ROOM/LOCATION: CANTEEN - FOOD PREP AREA  
 FEATURE/MATERIAL: FLOOR COVERING - VINYL TILES & ADHESIVE  
 SAMPLE NO.: SIMILAR TO: J163425-9235A-023

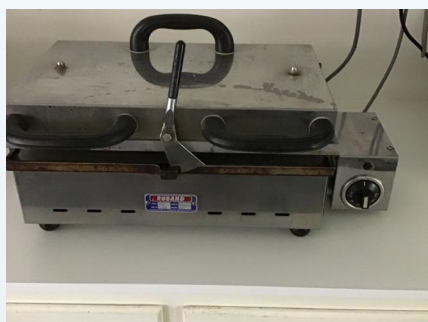
PHOTO NO.: J163425-9235A-PHOTO052  
 RESULT: ASBESTOS - PRESUMED POSITIVE  
 BUILDING/LEVEL: CHAPEL, BISHOP GALLAGHER, CANTEEN & STAFF BUILDING - GROUND LEVEL  
 ROOM/LOCATION: CANTEEN - FOOD PREP AREA  
 FEATURE/MATERIAL: PLANT & EQUIPMENT - INSULATION  
 SAMPLE NO.: NOT SAMPLED LIVE ELECTRICAL HAZARD

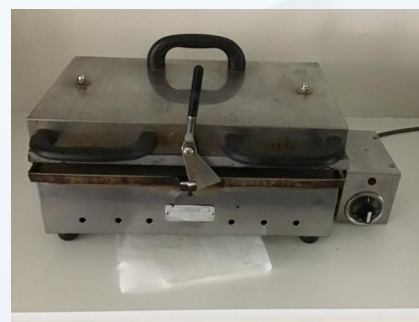
PHOTO NO.: J163425-9235A-PHOTO051  
 RESULT: ASBESTOS - PRESUMED POSITIVE  
 BUILDING/LEVEL: CHAPEL, BISHOP GALLAGHER, CANTEEN & STAFF BUILDING - GROUND LEVEL  
 ROOM/LOCATION: CANTEEN - FOOD PREP AREA  
 FEATURE/MATERIAL: PLANT & EQUIPMENT - INSULATION  
 SAMPLE NO.: NOT SAMPLED LIVE ELECTRICAL HAZARD

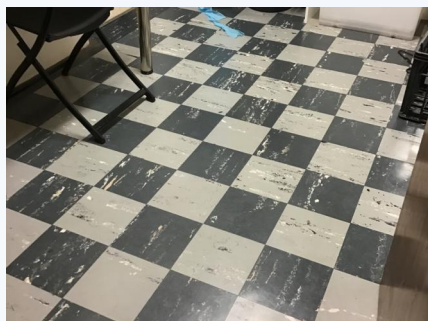
PHOTO NO.: J163425-9235A-PHOTO045  
 RESULT: ASBESTOS - POSITIVE  
 BUILDING/LEVEL: CHAPEL, BISHOP GALLAGHER, CANTEEN & STAFF BUILDING - GROUND LEVEL  
 ROOM/LOCATION: MAKEUP / STORE ROOM - THROUGHOUT  
 FEATURE/MATERIAL: FLOOR COVERING - VINYL TILES & ADHESIVE  
 SAMPLE NO.: J163425-9235A-023

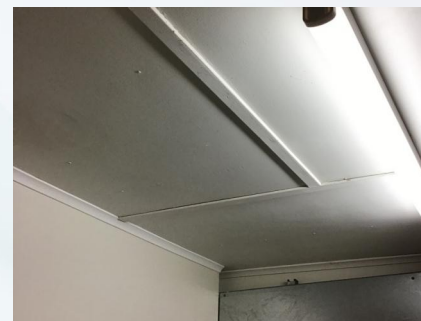
PHOTO NO.: J163425-9235A-PHOTO046  
 RESULT: ASBESTOS - POSITIVE  
 BUILDING/LEVEL: CHAPEL, BISHOP GALLAGHER, CANTEEN & STAFF BUILDING - GROUND LEVEL  
 ROOM/LOCATION: MAKEUP / STORE ROOM - WEST ROOM  
 FEATURE/MATERIAL: CEILING LINING - FIBRE CEMENT SHEETING  
 SAMPLE NO.: J163425-9235A-024

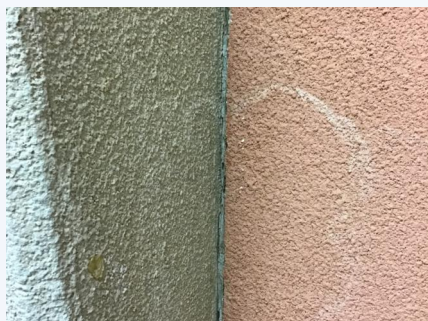
North & South Elevations Window Frames - Window Caulking - S	Asbestos	J163425-9235A-017	Negative											
Various Throughout Expansion Joint - Construction Joint Mastic	Asbestos	J163425-9235A-025	Positive	J163425-9235A-Photo047	75 m	Good	Non Friable	Low	Low	Not Labelled	26/08/2020	P4	Maintain in current condition, label and incorporate into an AMP. Remove by licensed asbestos contractor prior to demolition or refurbishment.	
<b>Chapel, Bishop Gallagher, Canteen &amp; Staff Building - Interior - Roof</b>														
Chapel, Main Hall - To Roof Beams Decorative Finish - Textured Coatings	Asbestos	Similar To: J163425-9235A-018	Presumed Negative

PHOTO NO.: J163425-9235A-PHOTO047  
 RESULT: ASBESTOS - POSITIVE  
 BUILDING/LEVEL: CHAPEL, BISHOP GALLAGHER, CANTEEN & STAFF BUILDING - GROUND LEVEL  
 ROOM/LOCATION: - VARIOUS THROUGHOUT  
 FEATURE/MATERIAL: EXPANSION JOINT - CONSTRUCTION JOINT MASTIC  
 SAMPLE NO.: J163425-9235A-025

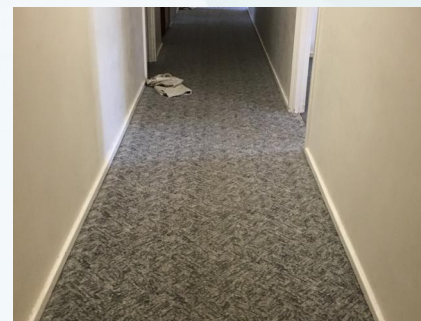
Rooms 11-18, including TV Rm & Passageway - Throughout, Beneath Carpets Floor Covering - Vinyl Tiles	Asbestos	J163425-9235A-008	Positive	J163425-9235 A-Photo015	250 m <sup>2</sup>	Not able to determine	Non Friable	Low	Low	Not Labelled	26/08/2020	P3	Encapsulated Beneath Carpet. Maintain in current condition, label and incorporate into an AMP. Remove by licensed asbestos contractor prior to demolition or refurbishment.	
---	----------	-------------------	----------	-------------------------	--------------------	-----------------------	-------------	-----	-----	--------------	------------	----	---	--

PHOTO NO.: J163425-9235A-PHOTO015  
 RESULT: ASBESTOS - POSITIVE  
 BUILDING/LEVEL: SALESIAN BOARDING HOUSE 1 - GROUND LEVEL  
 ROOM/LOCATION: ROOMS 11-18, INCLUDING TV RM & PASSAGEWAY - THROUGHOUT, BENEATH CARPETS  
 FEATURE/MATERIAL: FLOOR COVERING - VINYL TILES  
 SAMPLE NO.: J163425-9235A-008

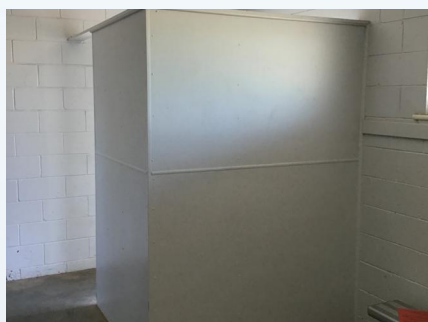
PHOTO NO.: J163425-9235A-PHOTO031  
 RESULT: ASBESTOS - POSITIVE  
 BUILDING/LEVEL: CHANGE ROOMS - GROUND LEVEL  
 ROOM/LOCATION: FEMALE CHANGEROOM - ADJACENT ENTRY DOOR  
 FEATURE/MATERIAL: PARTITION WALL - FIBRE CEMENT SHEETING  
 SAMPLE NO.: J163425-9235A-015

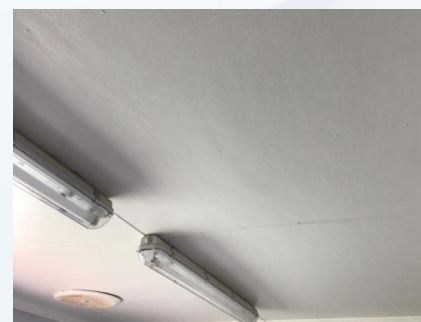
PHOTO NO.: J163425-9235A-PHOTO030  
 RESULT: ASBESTOS - PRESUMED POSITIVE  
 BUILDING/LEVEL: CHANGE ROOMS - GROUND LEVEL  
 ROOM/LOCATION: FEMALE CHANGEROOM - SHOWERS  
 FEATURE/MATERIAL: CEILING LINING - FIBRE CEMENT SHEETING  
 SAMPLE NO.: SIMILAR TO: J163425-9235A-013

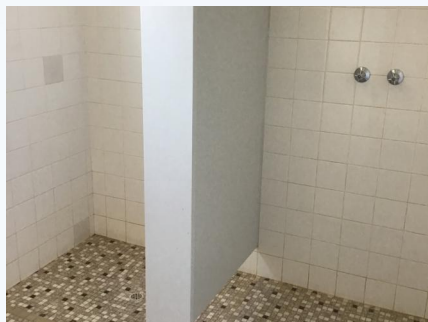
Female Changeroom - Showers Cubicle Partitions - Compressed Cement Sheeting	Asbestos	Similar To: J163425-9235A-014	Presumed Positive	J163425-9235A-Photo029	3 m <sup>2</sup>	Good	Non Friable	Medium	Low	Not Labelled	26/08/2020	P4	Maintain in current condition, label and incorporate into an AMP. Remove by licensed asbestos contractor prior to demolition or refurbishment.	
Female Changeroom - Toilet Ceiling Lining - Fibre Cement Sheeting	Asbestos	Similar To: J163425-9235A-013	Presumed Positive	J163425-9235A-Photo028	9 m <sup>2</sup>	Good	Non Friable	Low	Low	Not Labelled	26/08/2020	P4	Maintain in current condition, label and incorporate into an AMP. Remove by licensed asbestos contractor prior to demolition or refurbishment.	
Male Changeroom - Showers Ceiling Lining - Fibre Cement Sheeting	Asbestos	Similar To: J163425-9235A-013	Presumed Positive	J163425-9235A-Photo027	12 m <sup>2</sup>	Good	Non Friable	Low	Low	Not Labelled	26/08/2020	P4	Maintain in current condition, label and incorporate into an AMP. Remove by licensed asbestos contractor prior to demolition or refurbishment.

PHOTO NO.: J163425-9235A-PHOTO029  
 RESULT: **ASBESTOS - PRESUMED POSITIVE**  
 BUILDING/LEVEL: **CHANGE ROOMS - GROUND LEVEL**  
 ROOM/LOCATION: **FEMALE CHANGEROOM - SHOWERS**  
 FEATURE/MATERIAL: **CUBICLE PARTITIONS - COMPRESSED CEMENT SHEETING**  
 SAMPLE NO.: **SIMILAR TO: J163425-9235A-014**

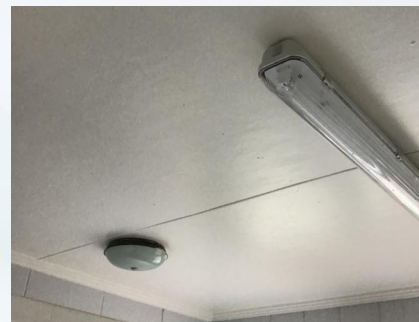
PHOTO NO.: J163425-9235A-PHOTO028  
 RESULT: **ASBESTOS - PRESUMED POSITIVE**  
 BUILDING/LEVEL: **CHANGE ROOMS - GROUND LEVEL**  
 ROOM/LOCATION: **FEMALE CHANGEROOM - TOILET**  
 FEATURE/MATERIAL: **CEILING LINING - FIBRE CEMENT SHEETING**  
 SAMPLE NO.: **SIMILAR TO: J163425-9235A-013**

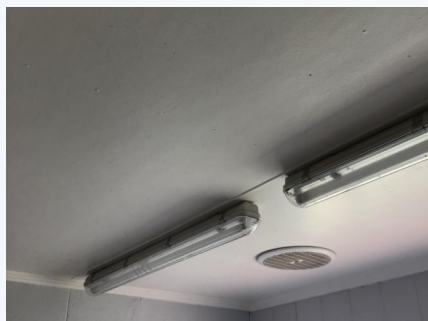
PHOTO NO.: J163425-9235A-PHOTO027  
 RESULT: **ASBESTOS - PRESUMED POSITIVE**  
 BUILDING/LEVEL: **CHANGE ROOMS - GROUND LEVEL**  
 ROOM/LOCATION: **MALE CHANGEROOM - SHOWERS**  
 FEATURE/MATERIAL: **CEILING LINING - FIBRE CEMENT SHEETING**  
 SAMPLE NO.: **SIMILAR TO: J163425-9235A-013**

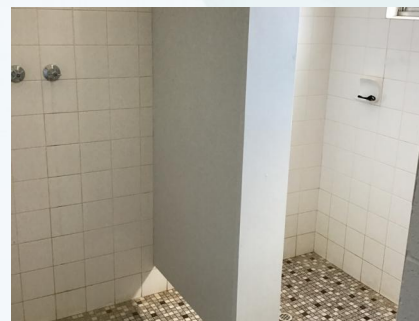
Male Changeroom - Showers Cubicle Partitions - Compressed Cement Sheeting	Asbestos	J163425-9235A-014	Positive	J163425-9235A-Photo026	3 m <sup>2</sup>	Good	Non Friable	Medium	Low	Not Labelled	26/08/2020	P4	Maintain in current condition, label and incorporate into an AMP. Remove by licensed asbestos contractor prior to demolition or refurbishment.	
Male Changeroom - Toilet Ceiling Lining - Fibre Cement Sheeting	Asbestos	J163425-9235A-013	Positive	J163425-9235A-Photo025	12 m <sup>2</sup>	Good	Non Friable	Low	Low	Not Labelled	26/08/2020	P4	Maintain in current condition, label and incorporate into an AMP. Remove by licensed asbestos contractor prior to demolition or refurbishment.

PHOTO NO.: J163425-9235A-PHOTO026  
 RESULT: **ASBESTOS - POSITIVE**  
 BUILDING/LEVEL: **CHANGE ROOMS - GROUND LEVEL**  
 ROOM/LOCATION: **MALE CHANGEROOM - SHOWERS**  
 FEATURE/MATERIAL: **CUBICLE PARTITIONS - COMPRESSED CEMENT SHEETING**  
 SAMPLE NO.: **J163425-9235A-014**

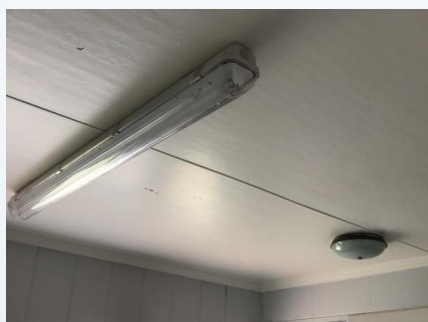
PHOTO NO.: J163425-9235A-PHOTO025  
 RESULT: **ASBESTOS - POSITIVE**  
 BUILDING/LEVEL: **CHANGE ROOMS - GROUND LEVEL**  
 ROOM/LOCATION: **MALE CHANGEROOM - TOILET**  
 FEATURE/MATERIAL: **CEILING LINING - FIBRE CEMENT SHEETING**  
 SAMPLE NO.: **J163425-9235A-013**
